ARBORIST'S REPORT

COUNTY CROSSINGS DEVELOPMENT WITHIN THE HILLCREST STATION AREA SPECIFIC PLAN

**City of Antioch
Contra Costa County, California**

October 2008

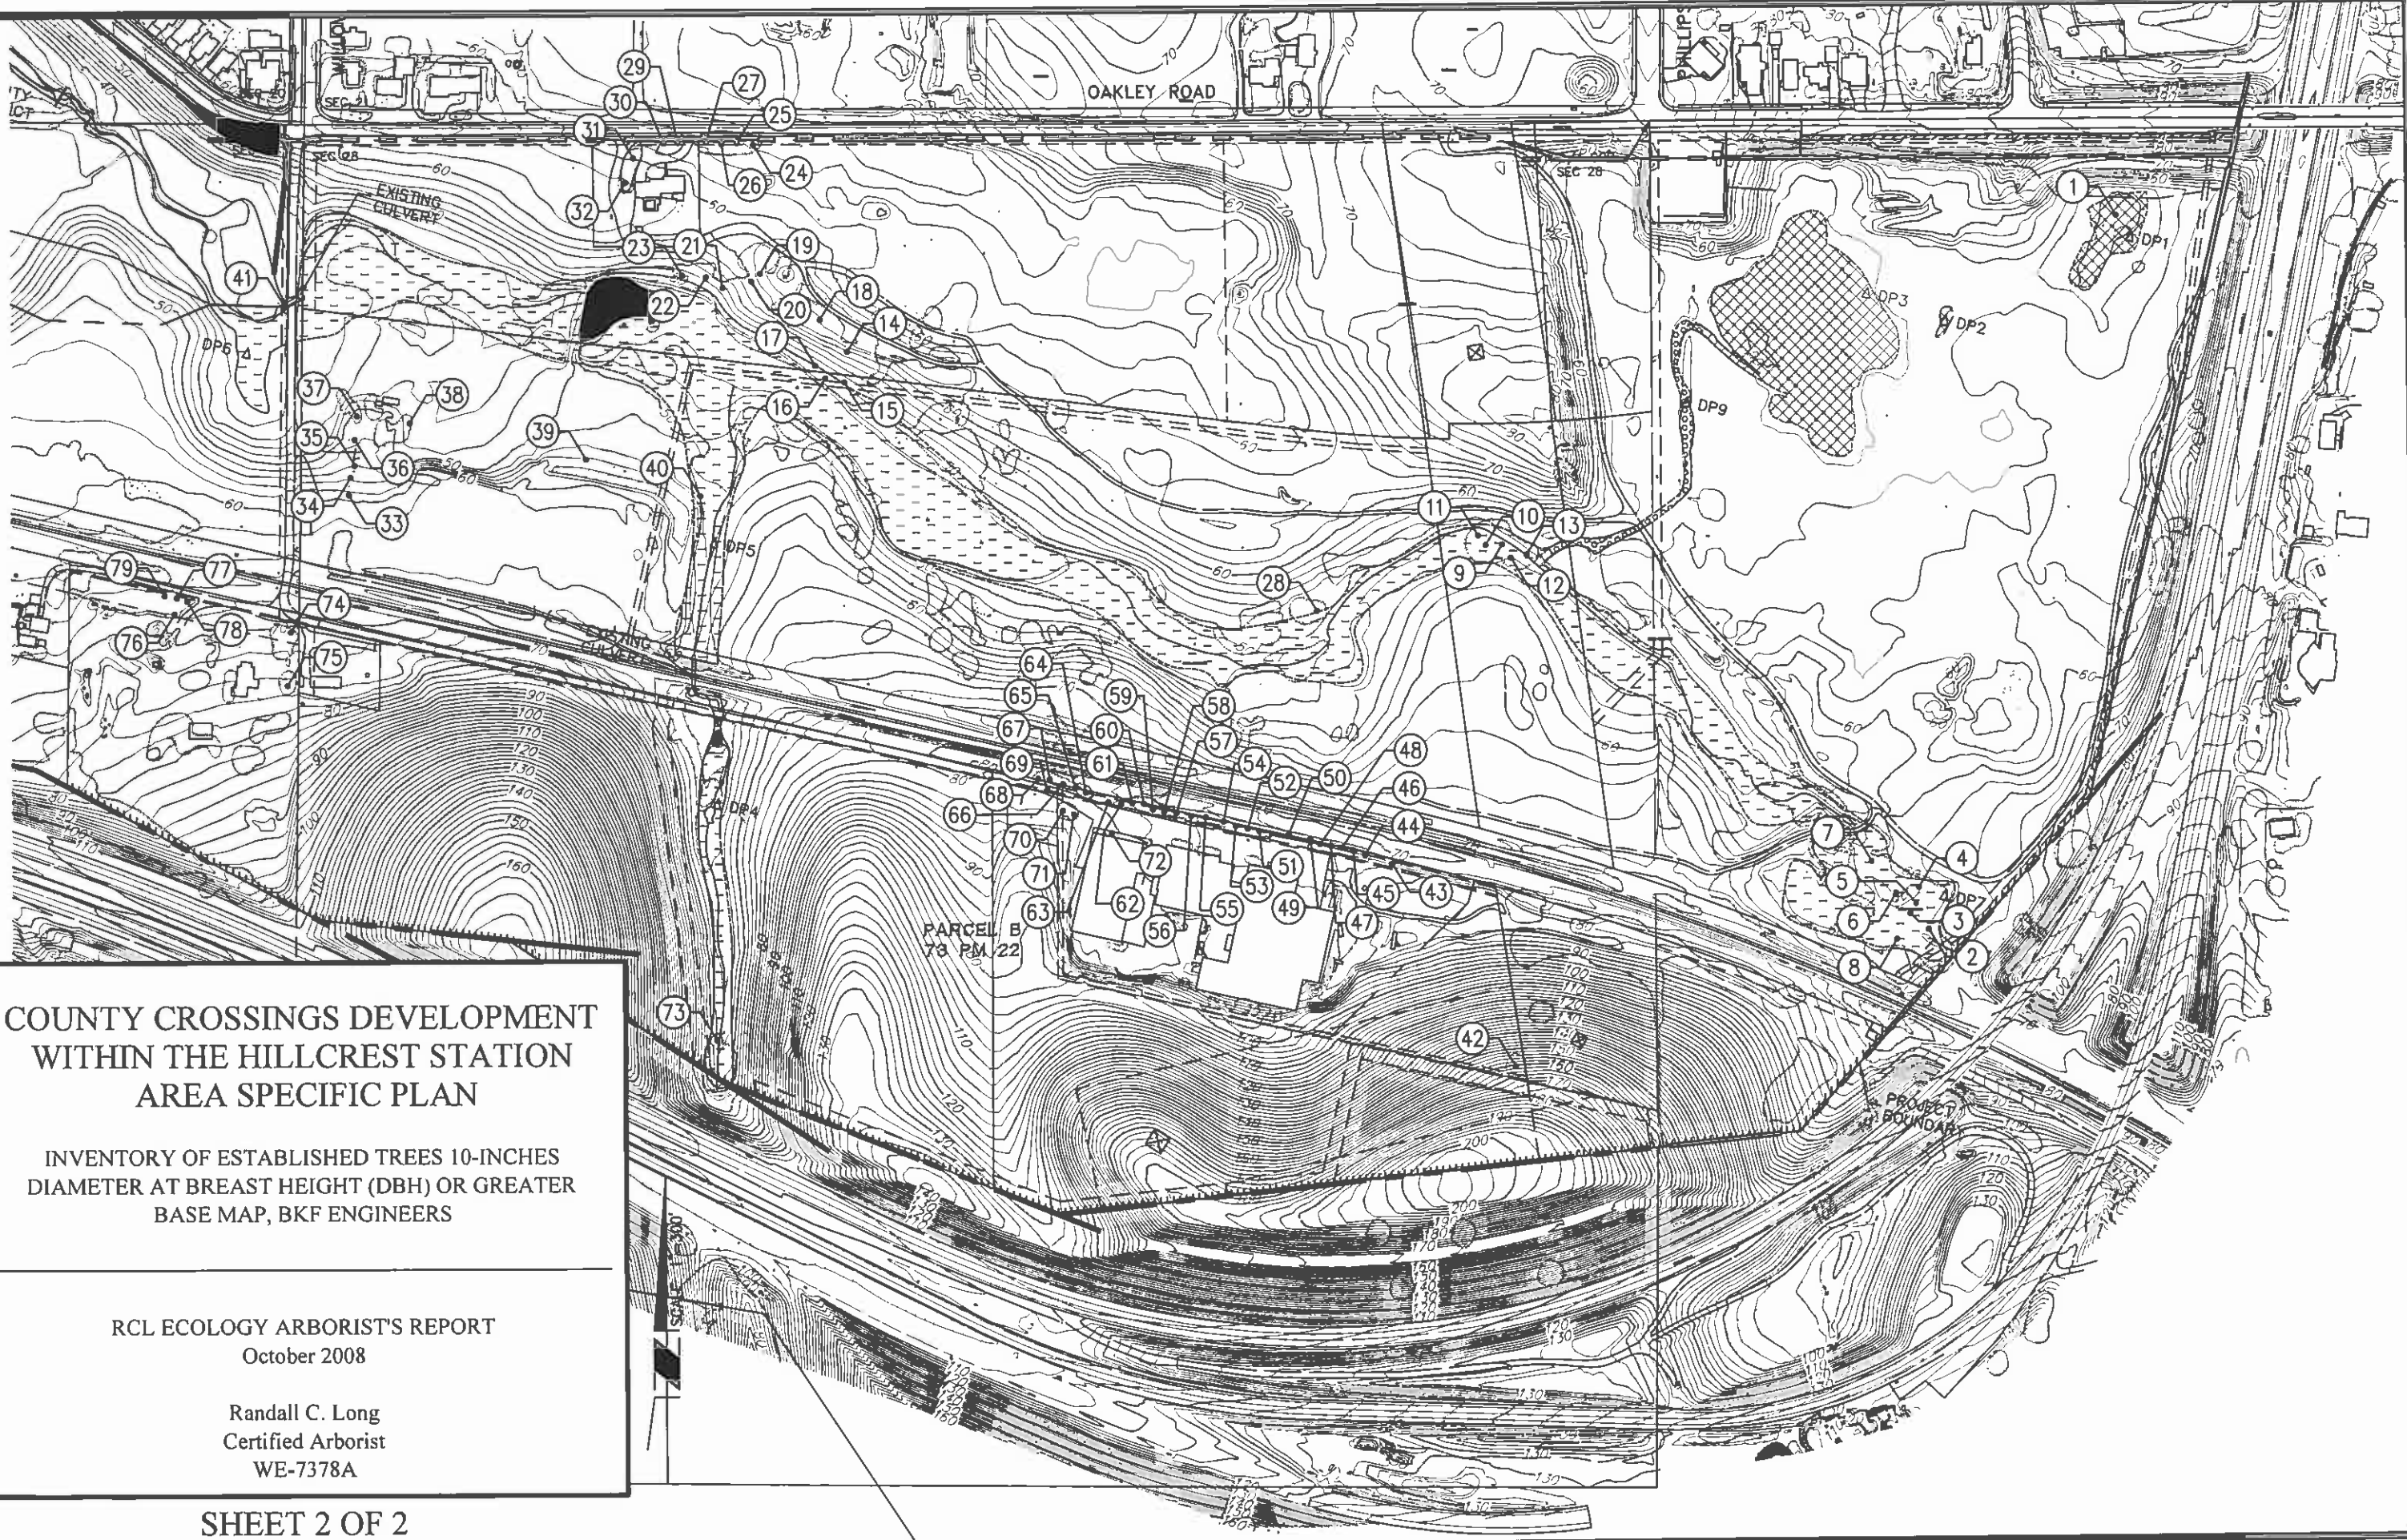
Tree Inventory Map

INVENTORY OF ESTABLISHED TREES 10-INCHES
DIAMETER AT BREAST HEIGHT (DBH) OR GREATER
BASE MAP, BKF ENGINEERS
